Manhole Inspection Summary

Manhole # S25C1_002MH

Location Address: **2401 Nevada St**

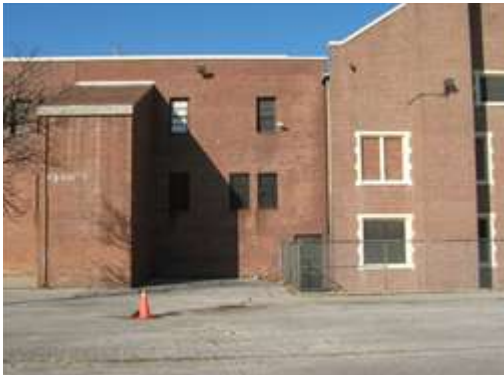
Location View

playground area behind 2401 Nevada St
(Westport Elementary School)

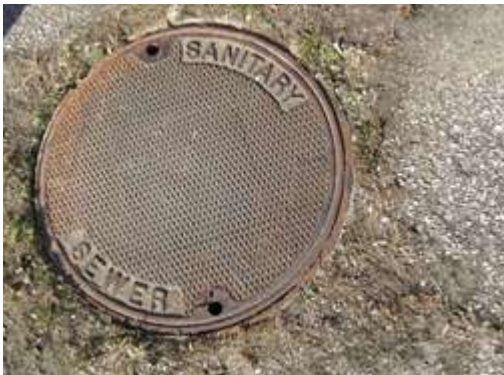
Misc

cover

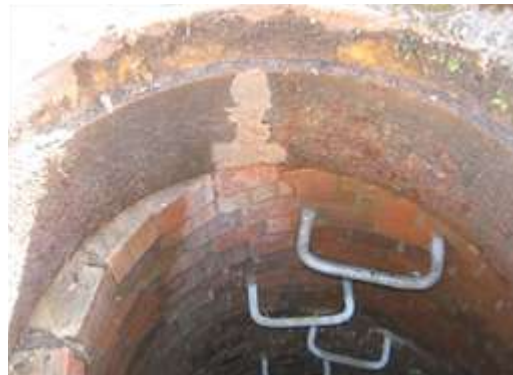
Defect 2

Offset: **3** (in.)

☒ **Leaks**

frame infiltration at cover, frame offset 3
inches

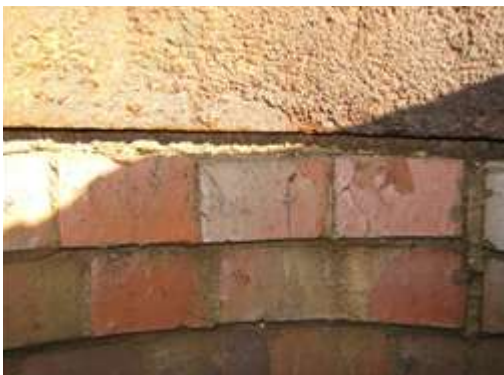
Defect 1

Condition: ☐ Sound ☐ Cracked ☐ Root Intrusion ☒ **Loose Brick** ☐ Deteriorated

Infiltration: ☐ None ☒ **Joint** ☐ Cracks ☒ **Mortar** ☐ Roots ☐ Wall

chimney loose bricks, chimney influent at
frame joint and mortar

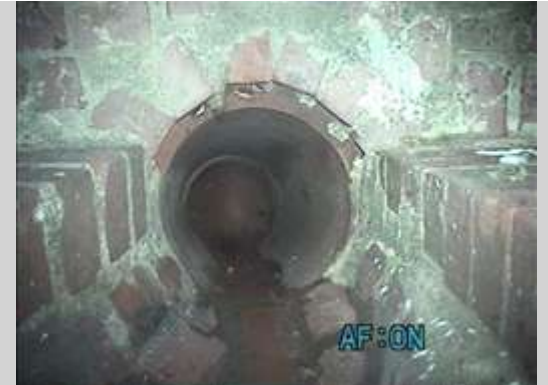
12 O'Clock Outflow

12 in. Circular Gravity Sewer
Pipe Out @ 12 O'Clock

Pipe Height: **12** (in.) Rod and Bar (Angled)
Pipe Material: **Clay** ☐ Pipe Lined
Invert Depth: **10.83** (ft.) Flow Characteristics: **Fast**
Deposits: ☒ None ☐ Mud ☐ Sludge ☐ Debris ☐ Grease
Silt Depth: **0** (in.) Deposits Extent:
Infiltration: **None** Pipe Seal Cond: **Sound**

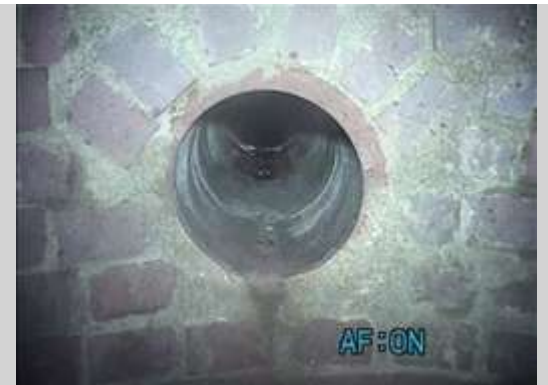
8 O'Clock Inflow

8 in. Circular Gravity Sewer
Pipe In @ 9 O'Clock

Pipe Height: **8.4** (in.) Rod and Bar (Angled)
Pipe Material: **Clay** ☐ Pipe Lined
Invert Depth: **8.35** (ft.) Flow Characteristics: **Fast**
Deposits: ☒ None ☐ Mud ☐ Sludge ☐ Debris ☐ Grease
Silt Depth: **0** (in.) Deposits Extent:
Infiltration: **None** Pipe Seal Cond: **Sound**

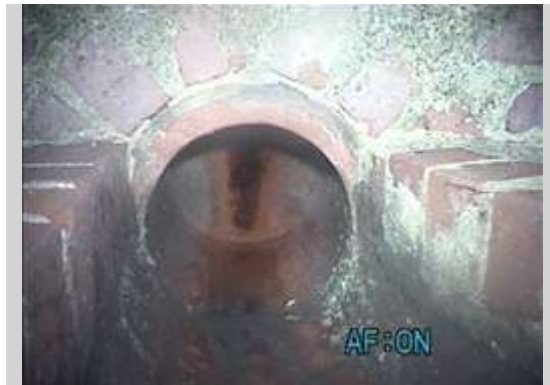
Drop In @ 9 O'Clock

Drop: **Inside** Rod and Bar
Angled: **Yes** Reading: **9.60** (ft.)
Inv Depth: **10.60** (ft.)
Drop Condition: **Open**
